GeoExplorer 2008 Series Handheld: Fitting the Hand Strap

This Support Note describes an issue with the Trimble® GeoExplorer® 2008 series hand strap that may be caused by applying excessive force to tighten its attaching screws.

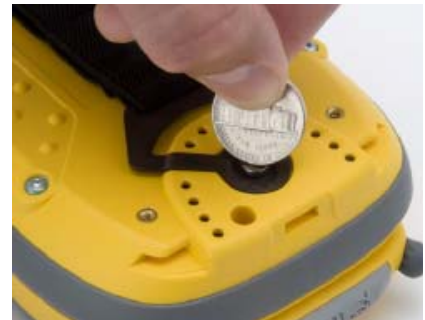
The hand strap on the GeoExplorer 2008 series handheld is attached with two screws, which you can tighten with a screwdriver or a coin, using only moderate force.

If you apply excessive force, the brass insert in the lower housing may strip and rotate within the housing. If this happens, you are not able to undo the screw to remove the hand strap as both the screw and insert rotate together. You can continue to use the hand strap as the insert will not pull out of the lower housing; you just cannot remove the hand strap from the handheld.

Docking with the support module or connecting to the serial clip are unaffected, and the environmental specifications of the handheld are not compromised.
